*flood plain information*

*MEADOW CREEK*

*albemarle county and  
charlottesville, virginia*

JANUARY 1972

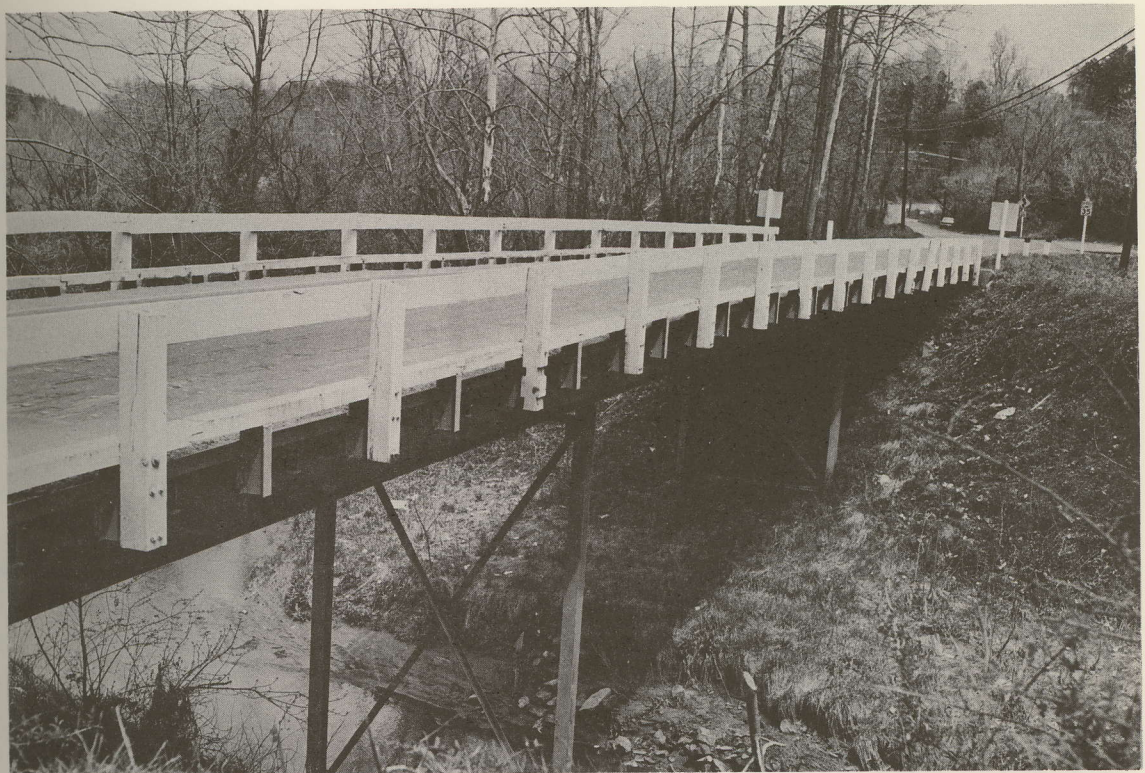
Figure 1 Bridges Across Meadow Creek

Holmes Avenue

Va. Route 631 (Park Street)

Table 4 shows that on Meadow Creek in the study area, only the Park Street crossing (Va. Rte 631) is completely above the level of expected flooding. The Holmes Avenue crossing would be inundated to a depth of about two feet during the Intermediate Regional Flood and to about six feet in the Standard Project Flood. The Southern Railway crossing would not be effected by the Intermediate Regional Flood but during the higher Standard Project Flood, water would rise to about six feet above the top of the culvert at this location. The Brandywine Drive crossing would remain open during the Intermediate Regional Flood but would be impassible during the Standard Project Flood. Hydraulic Road would be closed to traffic during both the Intermediate Regional Flood and Standard Project Flood. The U. S. 250 By-Pass culverts can accommodate the Intermediate Regional Flood but the carrying capacity of the two concrete culverts at this location would be exceeded during the Standard Project Flood, causing the roadway to be inundated to about one foot of depth. The roadways at two recently constructed culvert-type crossings near the upstream limits of the study area would be flooded during the Standard Project Flood. The roadway level of downstream structure would be above the level of the Intermediate Regional Flood but the upstream crossing would be flooded in this event.

Figures 1, 2, 3, and 4 are photographs of the bridges and culverts which carry highways and the railway across the study area.

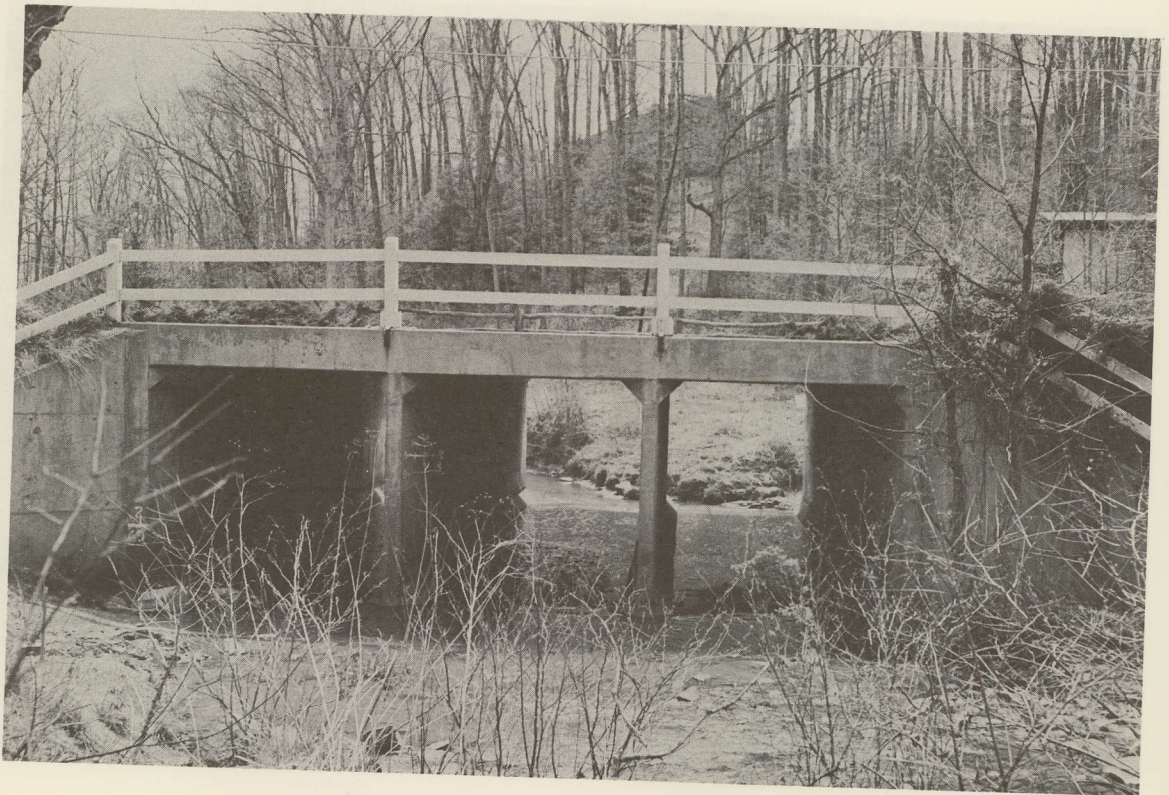
*Figure 2 Bridges Across Meadow Creek*

*Southern Railway*

*Brandywine Drive*

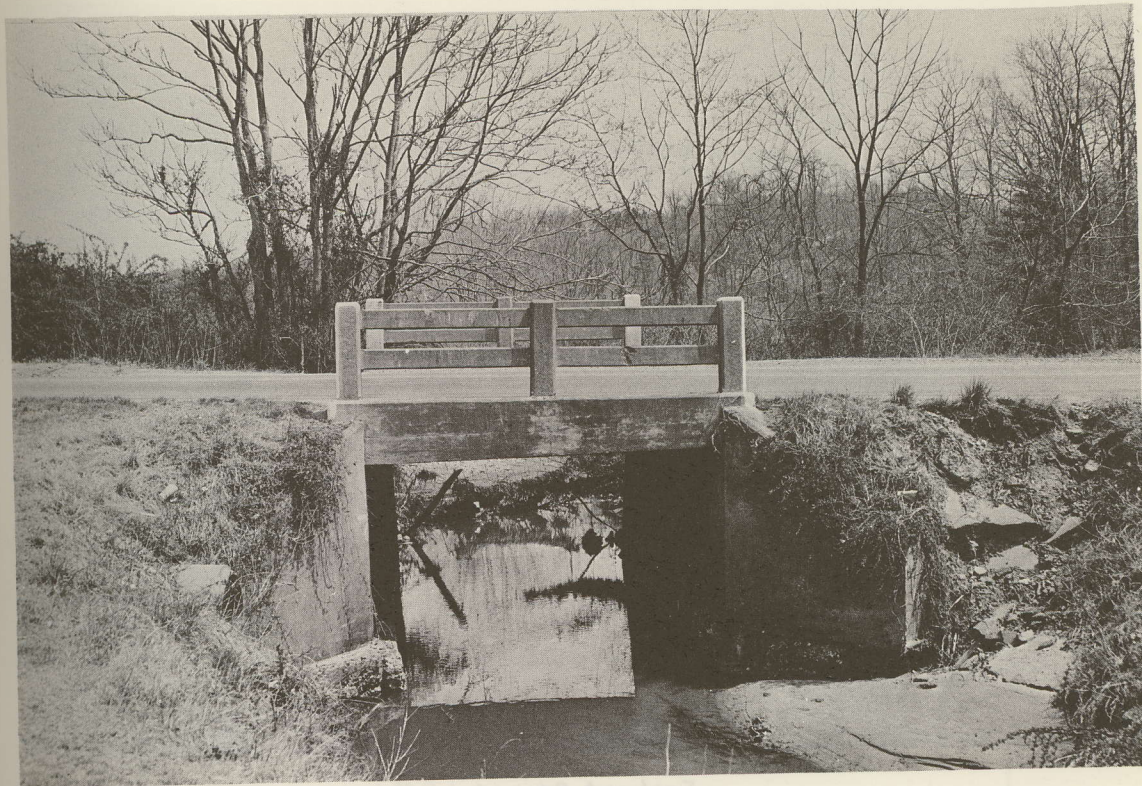
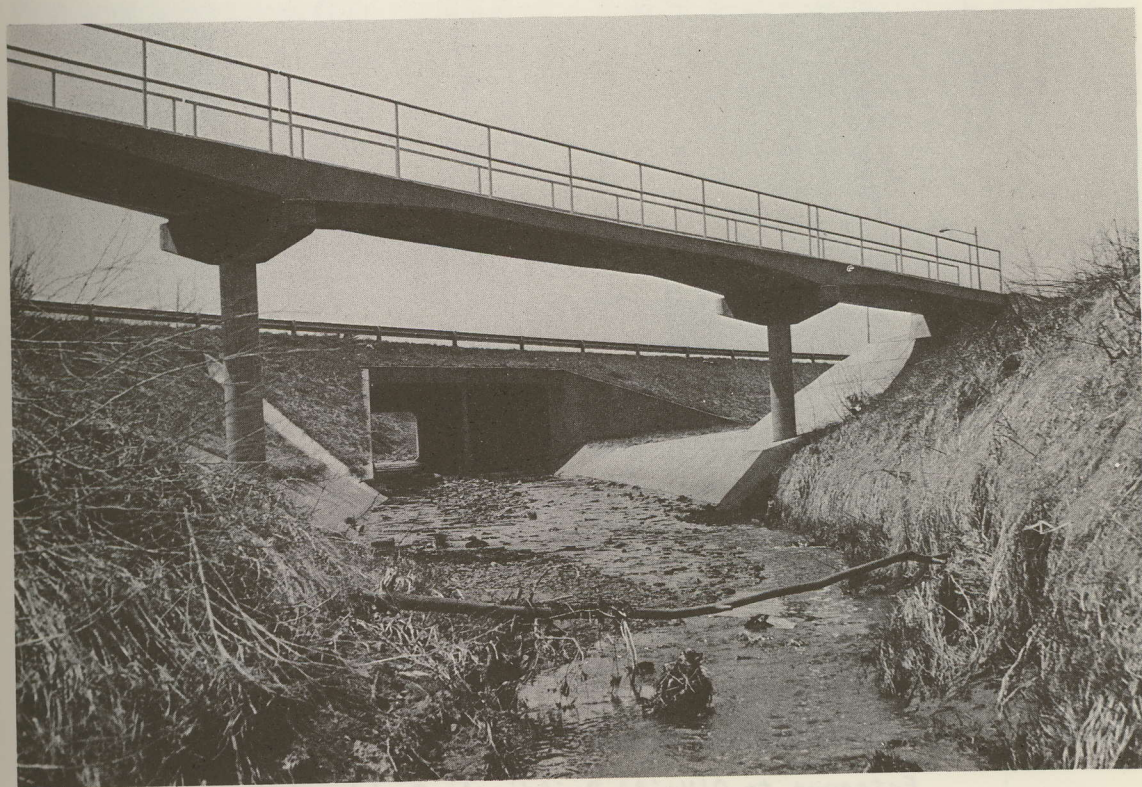
*Figure 3 Bridge Across Meadow Creek*

*Hydraulic Road*

*Pedestrian crosswalk and U.S. Route 250 Bypass*

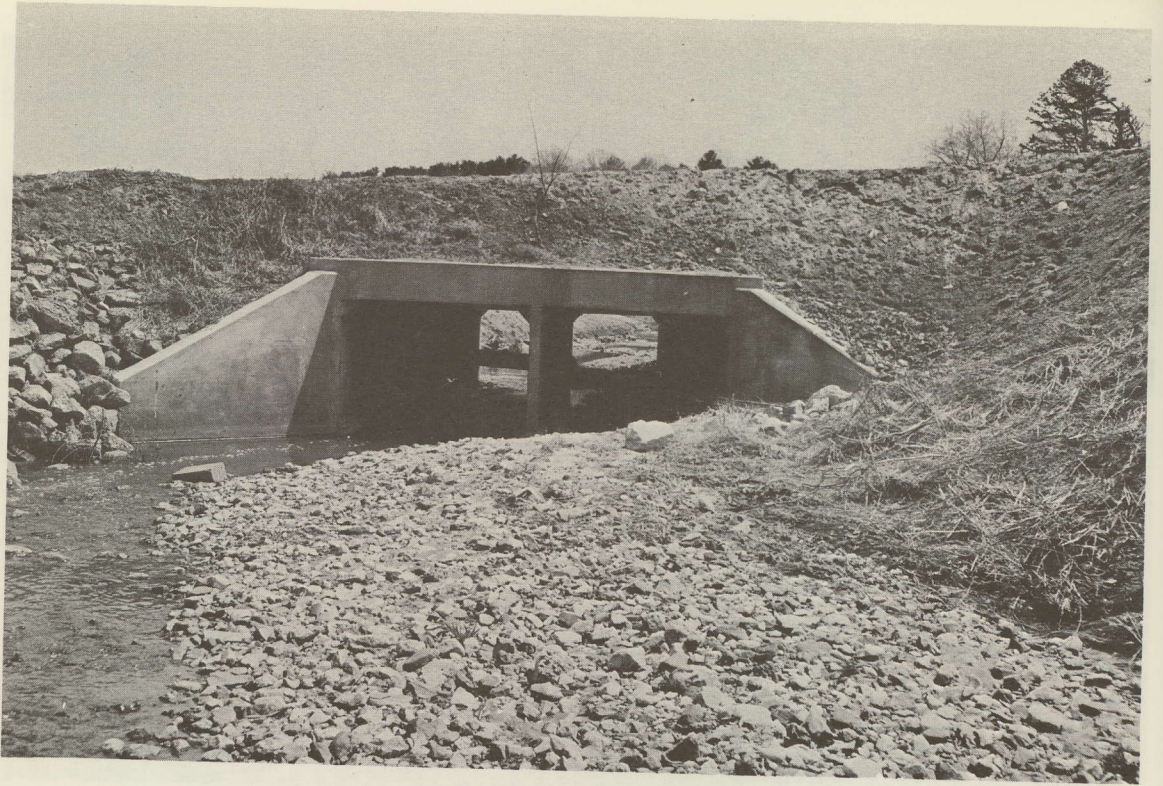
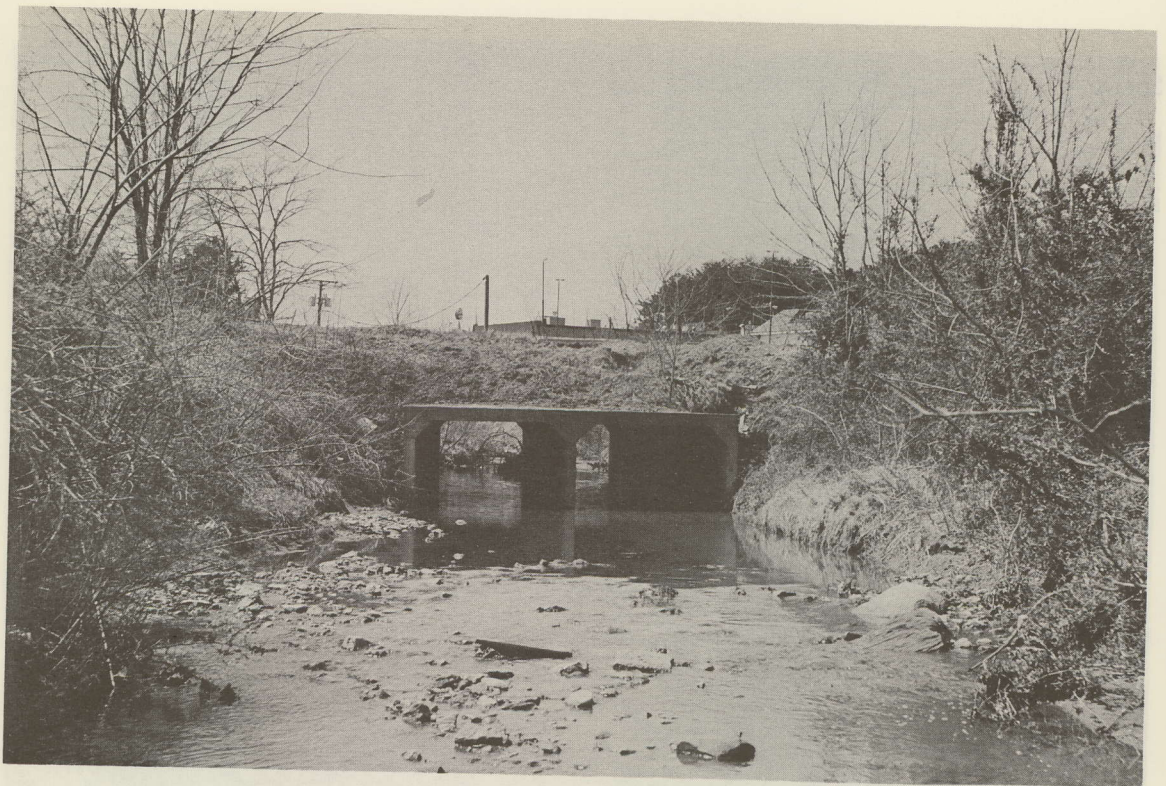
*Figure 4 Bridges Across Meadow Creek*

*Earhart Street*

*Entrance to O'Neill Building's Parking Lot*

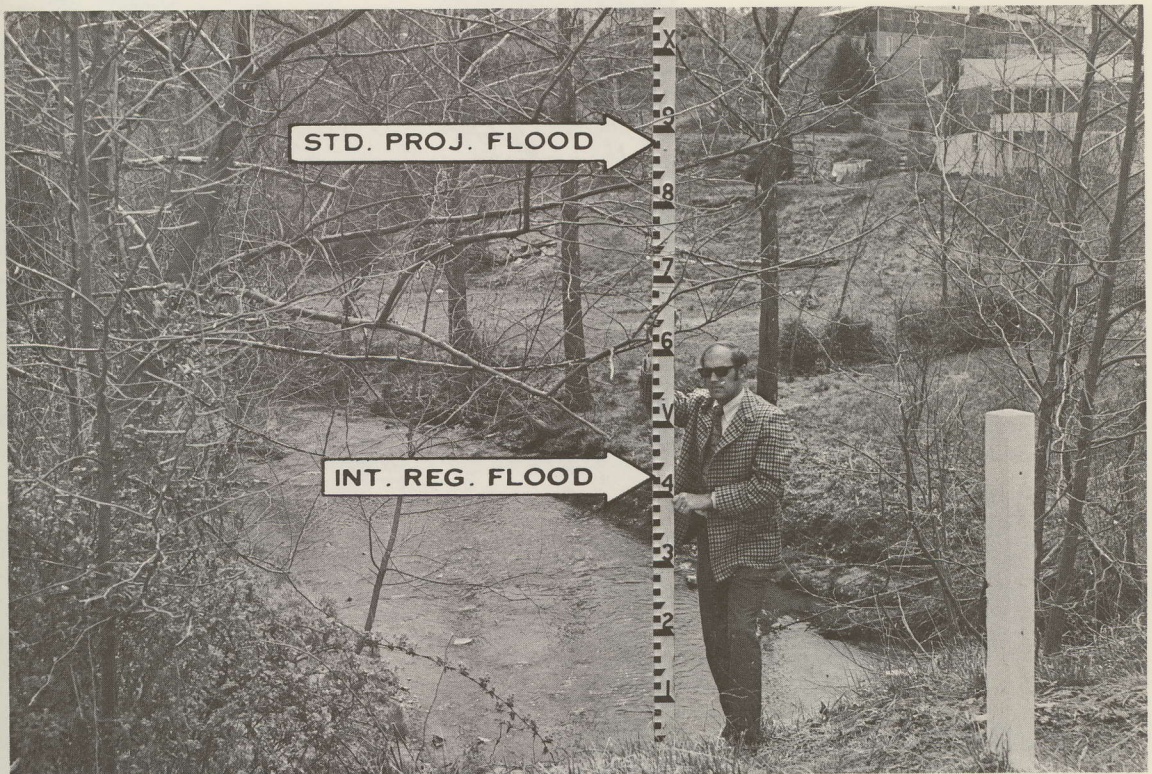
*Figure - 5 Flood Heights*

*Sewage Disposal Plant*

*Holmes Avenue Bridge*

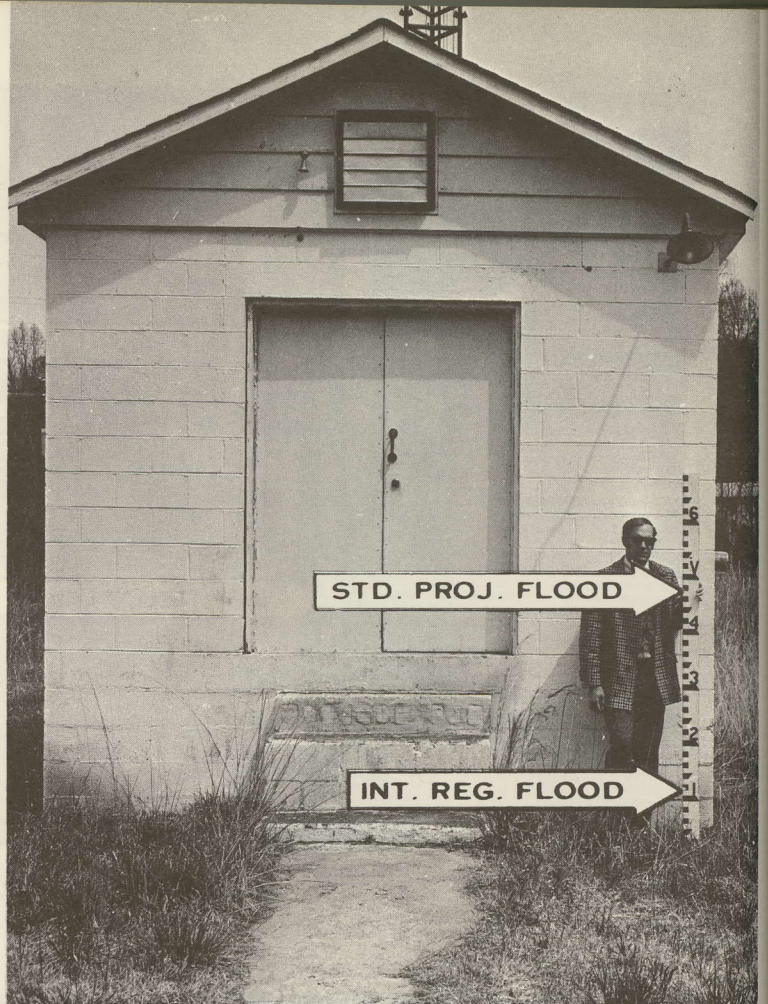
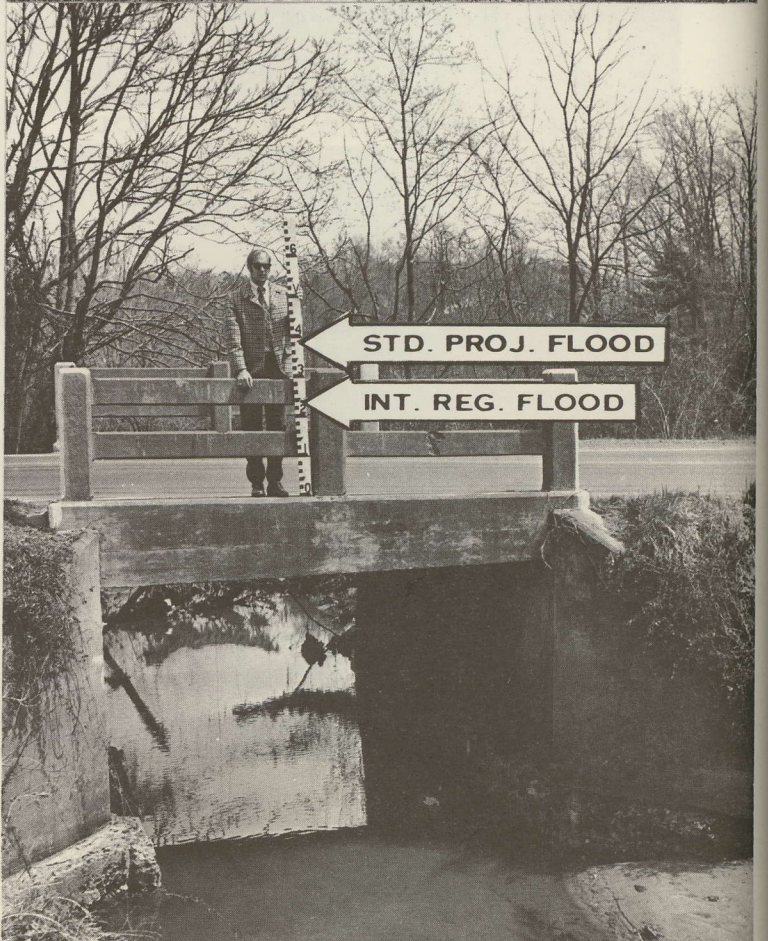
Figure 6 Flood Heights

Radio Tower near intersection  
of Milbourne Road and Park  
Street (Va. Route 631)

Hydraulic Road Bridge

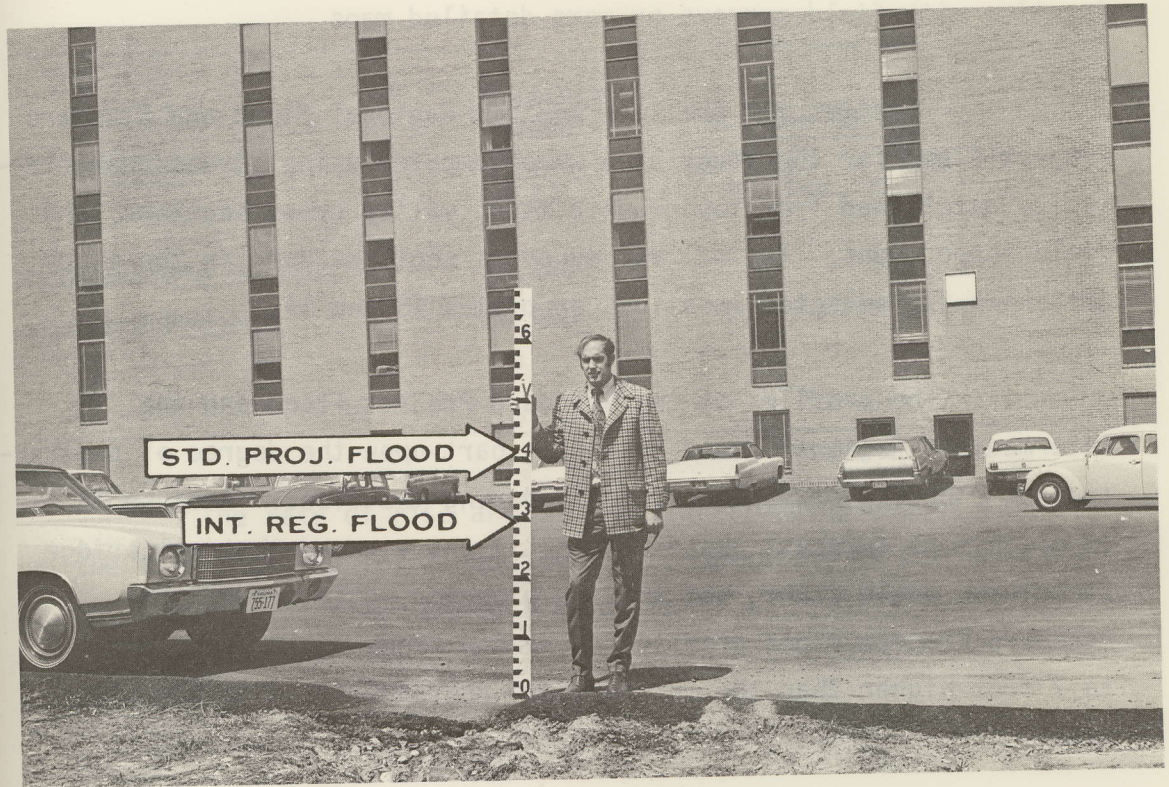
*Figure 7 Flood Heights*

*State Property on Brookway Drive*

*O'Neill Building's Parking Lot*
