# flood plain information MOORES CREEK albemarle county and charlottesville, virginia

This report covers the flood situation along Moores
Creek in the city of Charlottesville and in a portion of
Albemarle County, Virginia. The report was prepared at the
request of the governing bodies of Charlottesville and Albemarle
County through application to the Commissioner of the Division
of Water Resources, Department of Conservation and Economic
Development of the Commonwealth of Virginia. Its purpose is to
aid in defining local flood problems and in the best utilization
of land subject to overflow. The report is based on information
on rainfall, runoff, historical and current flood heights, and
other technical data bearing upon the occurrence and size of floods
along Moores Creek in the study area.

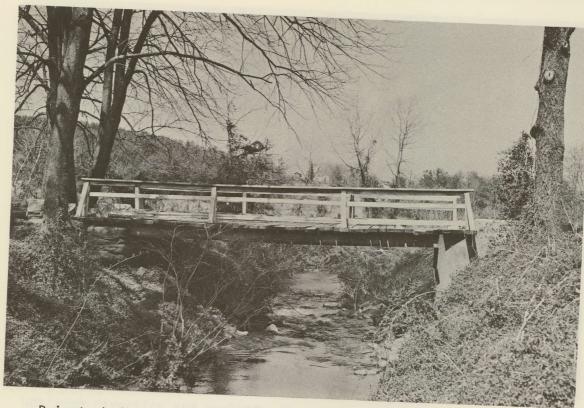
Figure 2. BRIDGES ACROSS BISCUIT RUN

Private bridge near mouth of Biscuit Run. (O'Neill Enterprises)

Interstate 64

Figures 1, 2, 3, 4, and 5 are photographs of the bridges and culverts which carry highways and railways across the study area.

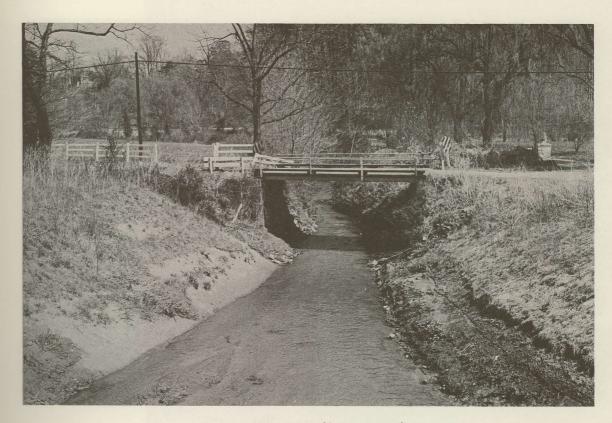
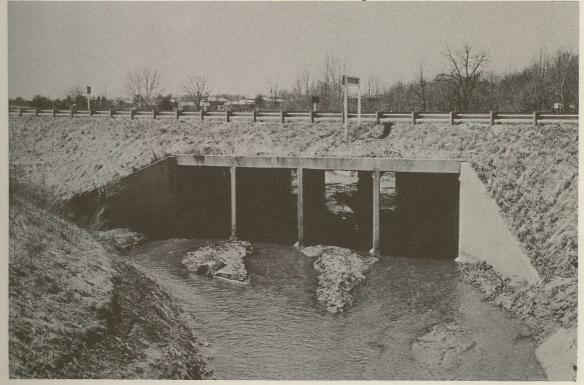
Figure 3. BRIDGES ACROSS MOORES CREEK

Va. Route 631 (Old Route)
FORMER HIGHWAY BRIDGE OVER MOORE'S CREEK
FOR "OLD LYNCHBURG ROAD"

Va. Route 631 (New Route) Now 5TH.ST.

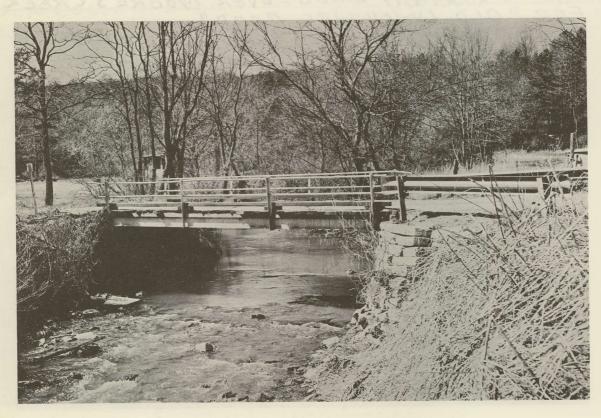
Figure 4. BRIDGES ACROSS MOORES CREEK

Va. Route 780

Sunset Avenue (Va. Route 781)

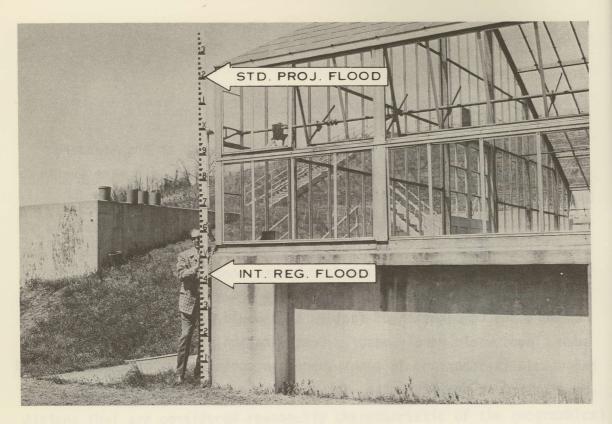
Figure 6. FLOOD HEIGHTS

Sewage Disposal Plant

Albemarle Livestock Market

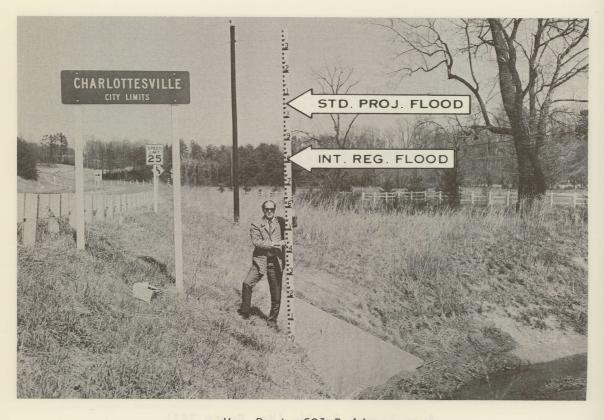
Bridge over Biscuit Run just upstream from its confluence with Moores Creek. (O'Neill Enterprises)

Va. Route 631 Bridge
Figure 8. FLOOD HEIGHTS
